## GEOINFORMATION IN GULLY EROSION STUDIES IN TAITA HILLS, SE-KENYA, PRELIMINARY RESULTS

Sirviö T., A. Rebeiro-Hargrave & P. Pellikka  
Department of Geography, P.O. Box 64, 00014 University of Helsinki, Finland  
e-mail: tommy.sirvio@helsinki.fi

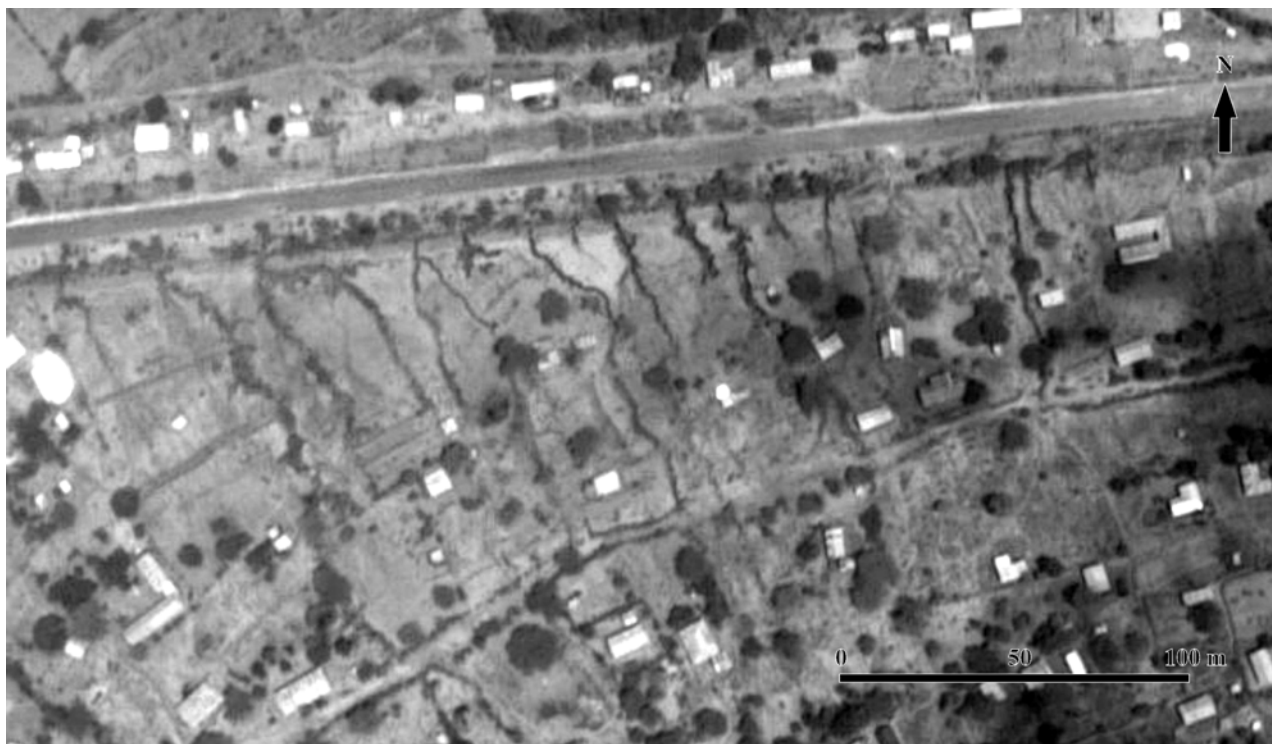
Figure 3. Gullies are extending to the squatters along the roadside in Mwatate. Aerial photograph orthomosaics (Photo from the year 2004, ground resolution app. 0.3 m) form the basis of the gully database of Taita Hills.

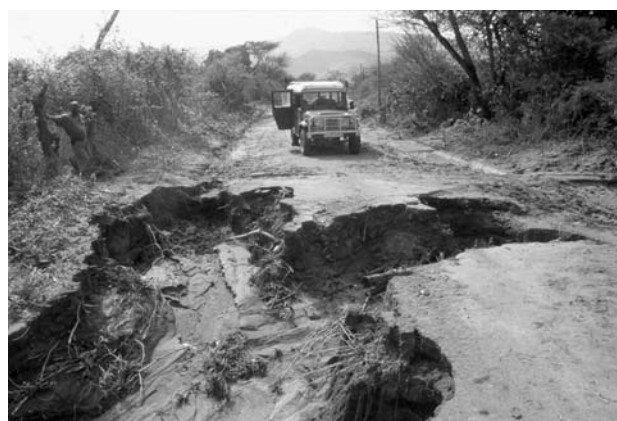
Figure 4. Rapidly extended gully has cut the road in Msau. (Photo: T. Sirviö)

Firstly, many agricultural activities including both farming and grazing are suffering from gully erosion, which decreases the quantity and quality of the agricultural land available. Secondly, the expanding gully systems are incising commercial sisal plantations. Finally, gully erosion is a serious threat to the constructed sites and affects both settlements, such as squatters in neighbouring town Voi (Hurskainen, 2004), Mwatate and (Figure 3) and roads (Figure 4), the condition of which, especially during the rainy season, is noted to be very poor (Hermunen *et*

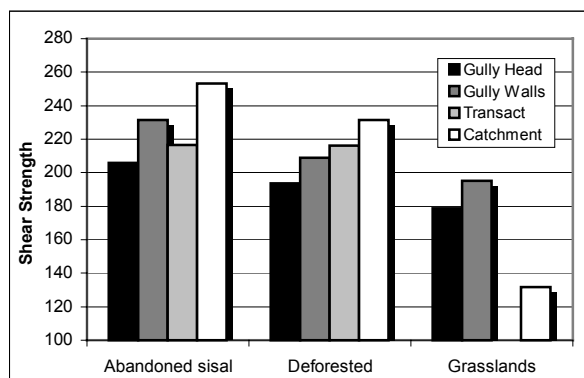
Figure 5. Average shear strength measurements from gully heads and catchments (n=236 plots).

Conversely, average shear strength taken from catchment areas with reasonable vegetation cover is high, as shown in Figure 5. These measurements are associated with tree and sisal roots, which increase soil strength within the soil column.

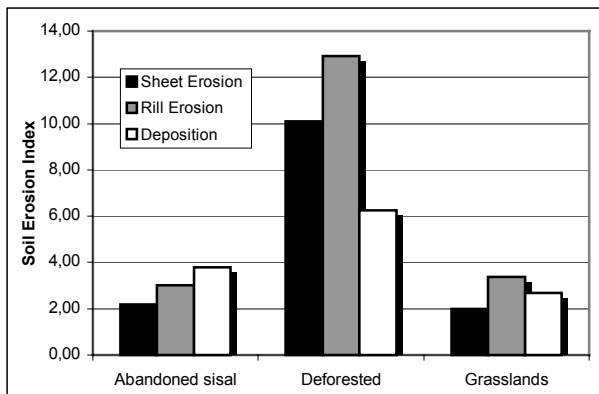
Figure 6. Average Soil Erosion Indexes (SEI) compared to field observations of erosion forms.

A comparison between the field classification of erosion forms and spectral analysis of soil samples taken from the field plots (n=236) show deforested and overgrazed area with high soil erosion index values, as illustrated in Figure 6.

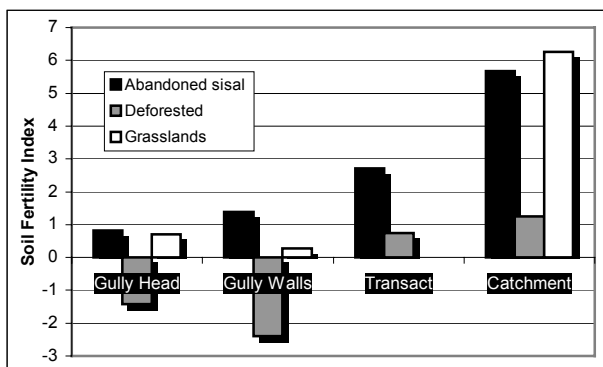
Figure 7. Average spectral index of soil fertility (SFI) from gully heads and catchments. There is a clear reduction of soil fertility in the gullied areas when compared to the catchment areas.

The distribution of spectral soil fertility index (SFI) shows carbon content of the surface soil decreasing from the catchment area towards the gully head, as depicted in Figure 7. There are marked differences between the studied locations.

Mwatate, representing sisal abandonment, has low soil fertility in the gullied area, moderate values along the transects, and high values in the catchment area. Msau, representing deforestation and overgrazing, has negative soil fertility around the gullied area and small values in the catchment areas, which have been overgrazed. Chawia, representing overgrazed grasslands, also has low soil fertility values around the gully head.
